## **CASE REPORT**

# The 'tail' of a missing intrauterine contraceptive device

The Journal of Family Planning and Reproductive Health Care 2002: 28(2): 96-97

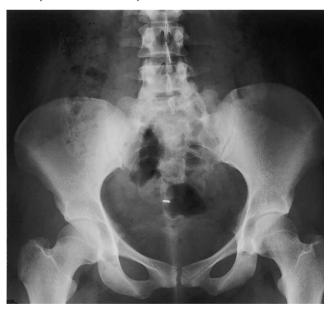
The radiographer stated that she was unable to demonstrate the IUD in the uterine cavity, therefore an abdominal x-ray was performed. The IUD was identified in the midline of the pelvis (Figure 2). Arrangements were therefore made for a consultation with the community gynaecologist to discuss further management. The patient

Figure 2 Pelvic x-ray: the IUD is identified in the midline in the pelvis but it is not possible to be certain of its exact location in relation to the uterus

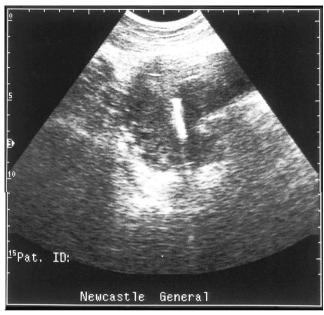
Figure 3 Second pelvic ultrasound [transabdominal (TA) scan]: the IUD can be seen within the uterine cavity which appears to be correctly positioned

central clinic clearly identified the IUD lying within the uterine cavity (Figure 3). The IUD was removed easily with Alligator forceps (Figure 4). These forceps have serrated jaws and open in one direction. The forceps were introduced through the cervix. The jaws opened to grasp the IUD, which was then removed.

The key issue in this patient's case was the avoidance of unnecessary intervention primarily due the accuracy of the second ultrasound examination. It is clear from the outcome in this patient's case that the first ultrasound examination was carried out by a less skilled operator. We recommend that only trained staff should undertaken ultrasound examinations in clinical settings.
