## Removal of a fractured Nexplanon<sup>®</sup>

*J Fam Plan Reprod Health Care* 2013;**39**:66–67.  
doi:10.1136/jfprhc-2012-100491

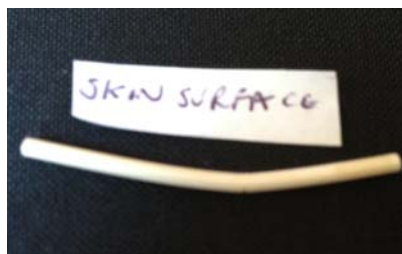
When she returned for the removal she said that the implant “felt like it had a dip in it”, which she had noticed 2 weeks previously. The implant did feel as if there was a difference along its length with regard to the depth below the skin. On removal via the pop-out procedure from the distal end it was found to be curved to about 10° roughly halfway along its length, with a noticeable breach in the convex surface of the curvature (Figure 1). The patient said she

**Figure 1** The implant following removal showing the obvious curvature roughly halfway along its length, with a noticeable breach in the convex surface of the curvature.

had not had any trauma to the arm prior to noticing the difference in shape. As discussed in Pickard and Bacon's report,<sup>1</sup> there may be a reduction in contraceptive effect if the implant is fractured, and this may be because of the larger surface area from which the progestogen is released. Fortunately in this case the woman was already protected by another contraceptive method at the time that she noticed the change in the implant. There remains the question as to how this curvature and non-continuity of the rod occurred, and I wonder if any other clinicians have observed anything like this.
