Removal of a fractured Nexplanon®

J Fam Plan Reprod Health Care 2013;**39**:1.
doi:10.1136/jfprhc-2012-100491

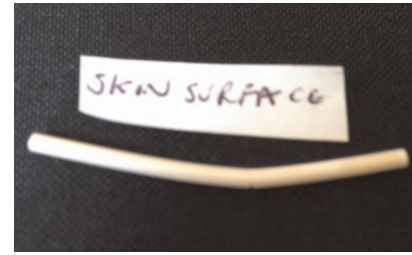
previously. The implant did feel as if there was a difference along its length with regard to the depth below the skin. On removal via the pop-out procedure from the distal end it was found to be curved to about 10° roughly halfway along its length, with a noticeable breach in the convex surface of the curvature (Figure 1). The patient said she had not had any trauma to the arm prior to noticing the difference in shape. As discussed in Pickard and Bacon's report,¹ there may be a reduction in contraceptive effect if the implant is fractured, and this may be because of the larger surface area from which the progestogen is released. Fortunately in this case the woman was already protected by another contraceptive method at the time that she noticed the change in the implant. There remains the question as to how this curvature and non-continuity of the rod occurred, and I wonder if any other clinicians have observed anything like this.

Figure 1 The implant following removal showing the obvious curvature roughly halfway along its length, with a noticeable breach in the convex surface of the curvature.
