Perforation with the GyneFix[®] intrauterine implant: is there a common factor?

Thomas R Aust, MB ChB, *Research Fellow*; **John N Kirwan**, MRCOG, *Macmillan Fellow*; **J Jonathan O Herod**, BSc, MRCOG, *Consultant Gynaecological Surgeon and Oncologist, Department of Gynaecology, Liverpool Women's Hospital, Liverpool*; **James T McVicker**, MRCGP, MFFP, *Associate Specialist, Abacus Centre for Contraception and Reproductive Health, Liverpool, UK*

Journal of Family Planning and Reproductive Health Care 2003; **29**(3): 155–156

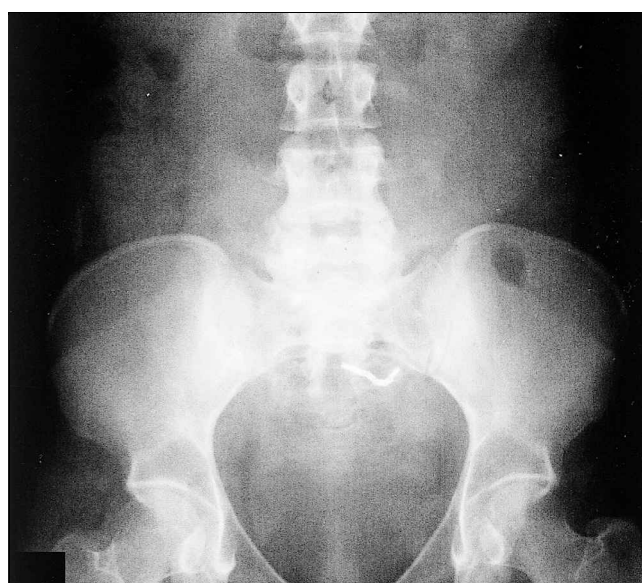
A 22-year-old nulliparous woman underwent fitting of a GyneFix[®] intrauterine contraceptive device (IUD) at a family planning clinic. She had previously been using Depo-Provera[®] continuously for 4 years. Chlamydia screening at that time was negative and the procedure was carried out without incident by a clinician experienced in the insertion of this type of IUD. Two months later she returned to have the device removed in order to start a family but the threads could not be visualised. An ultrasound scan showed no evidence of the device within the uterus and an abdominal radiograph showed an extrauterine IUD in the midline above the pelvic brim (Figures 1 and 2).

Figure 1 AP abdominal radiograph showing the perforated GyneFix

At operation the GyneFix device was seen in an omental adhesion in the midline attached to the anterior abdominal wall. The omentum was dissected away revealing the GyneFix with its knot embedded in the abdominal wall. The device was retrieved laparoscopically and the patient was discharged home the same day.

This is the sixth case report of a perforation with this device (Table 1). Overall, five of the devices were removed either laparoscopically or by laparotomy. The remaining device was thought to have been passed out of the abdomen via the intestines.¹ Copper IUDs such as the GyneFix are thought to predispose the patient to adhesions once inside the peritoneal cavity. It is this adhesion risk, coupled with the patients' concern about the presence of a foreign object free in their abdomen, which leads to the devices being retrieved in theatre. The manufacturers of GyneFix recommend that perforated devices should be removed.

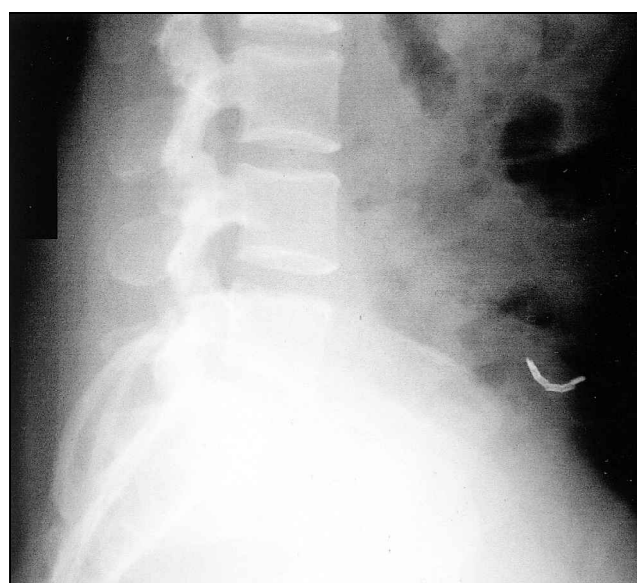
Figure 2 Lateral abdominal radiograph. The six copper beads are clearly seen situated outside the pelvis
