The impalpable Implanon®: a case report

Journal of Family Planning and Reproductive Health Care 2003; **29**(3): 156–157

This is a case report of an Implanon® contraceptive device that was impalpable after insertion and a discussion of the management of the impalpable Implanon.

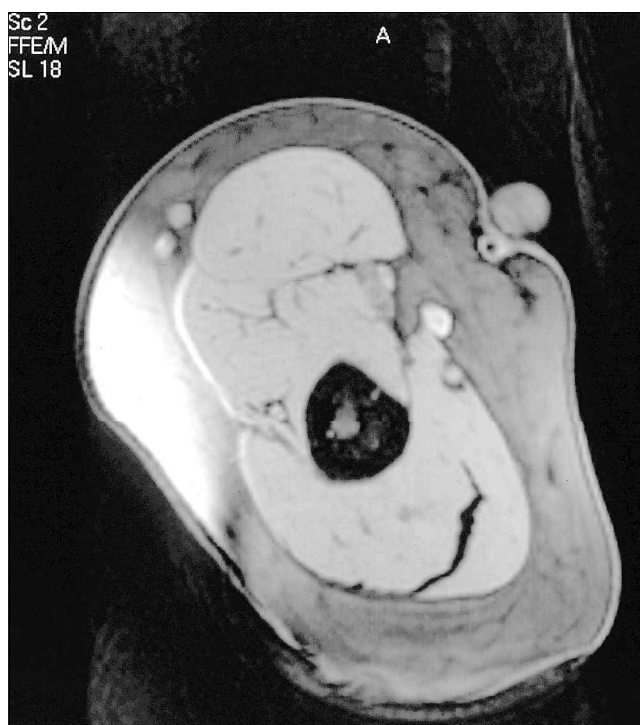
Figure 1 An MRI T1 axial image showing the Implanon as a signal void in the subcutaneous tissues, deep to an oil capsule taped to the skin surface at the site of insertion. Note the high signal rim surrounding the device

The MRI scan revealed a single device in the subcutaneous fat. Localisation was aided by placing an oil capsule on the skin, at the site of insertion. A surface coil is necessary for the best image quality.

Figure 1 shows the Implanon in axial section, as a low signal (black) structure, or signal void, just beneath the skin, with surrounding high signal (white) rim. Higher signal from the adjacent subcutaneous fat acts as contrast. Figure 2 is a coronal section using a fat suppression sequence (STIR). The Implanon has a low signal, and would be lost against the background low signal of subcutaneous fat, but is highlighted by a ragged high signal rim. This high signal represents the oedema following insertion, which persists for several days.

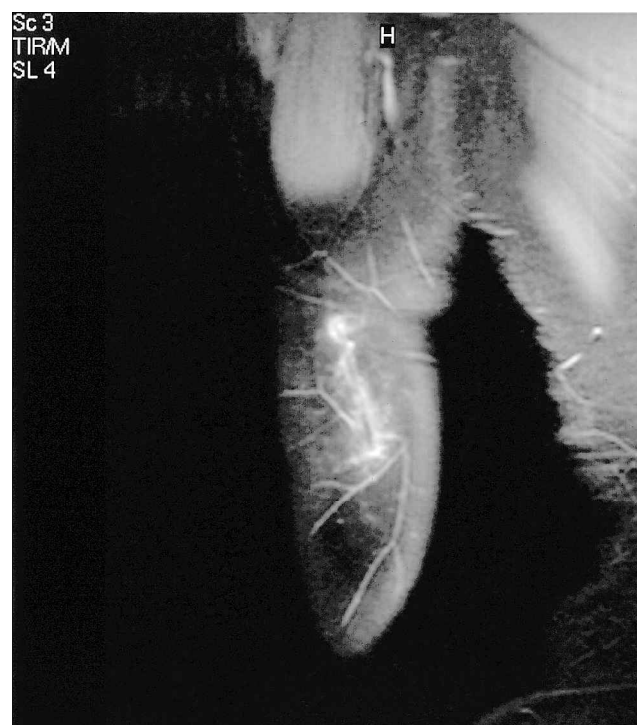
Figure 2 An MRI coronal, fat suppression (STIR) sequence shows the Implanon as a long, thin structure, with surrounding ragged area of high signal representing the oedema and inflammation at the injection site
