Migration of Implanon®: two case reports

J Fam Plann Reprod Health Care 2005; **31**(1): 71-72
(Accepted 3 June 2004)

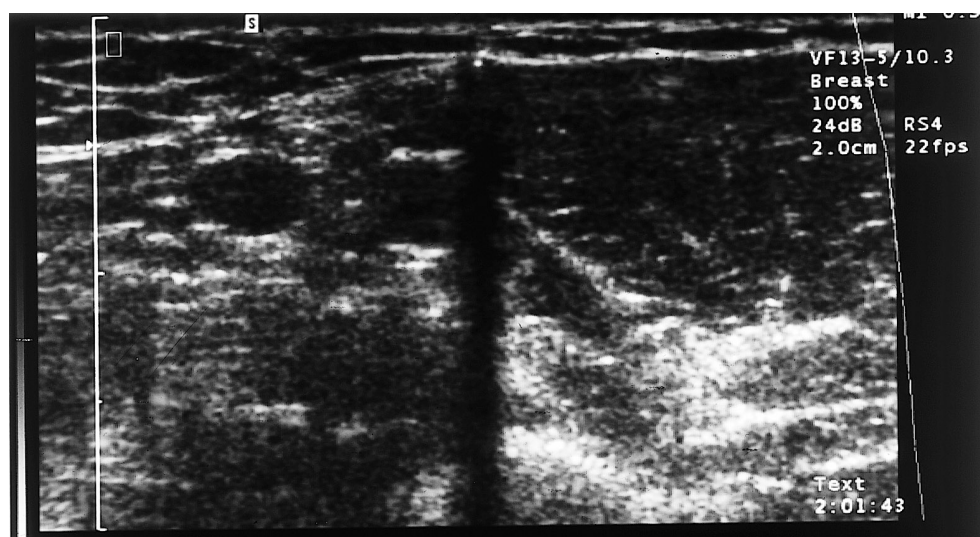
Figure 1 Ultrasound image showing the subcutaneous location of the distal end of the Implanon® device in Case 2 as noted by posterior acoustic shadow

When she attended for renewal in February 2003 the Implanon was not palpable. Ultrasound examination, using a 13.5 MHz linear array transducer, located the distal end subcutaneously (Figure 1) 7.3 cm from the insertion site (as noted by a 2 mm white scar on the upper arm). The proximal end was lying 5 mm deep and close to the neurovascular bundle in the upper arm (Figure 2).

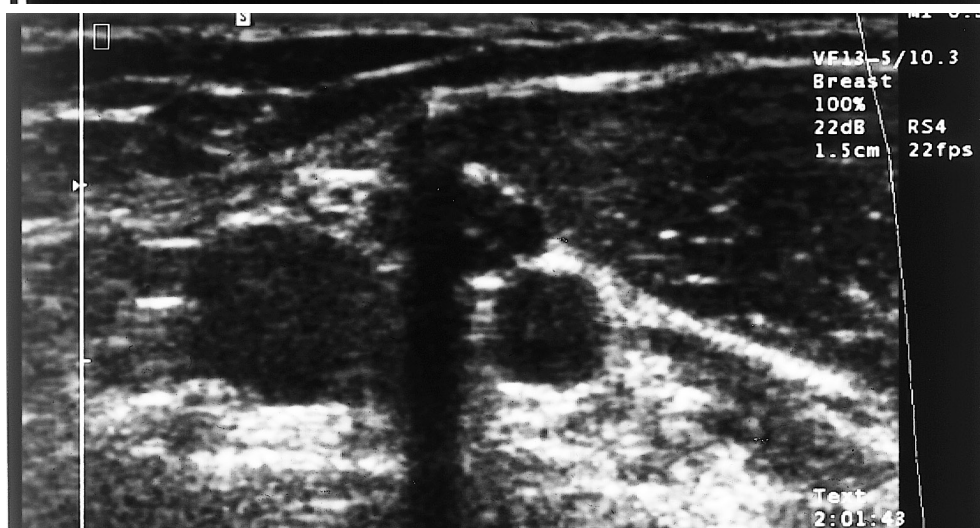
Figure 2 Ultrasound image showing the location of the proximal end of the Implanon® device in Case 2 lying close to the neurovascular bundle

This woman has congenital heart disease with shunt, requires oxygen at night, and is fully anticoagulated with warfarin. Subcutaneous infiltration with local anaesthetic for attempted removal of the Implanon under ultrasound guidance resulted in haematoma formation and the procedure was abandoned. After discussion, it was decided to leave the original Implanon *in situ* permanently rather than risk removal.
