Migration of Implanon®: two case reports

These two case reports describe migration of Implanon® (the single-rod contraceptive implant). A review of the literature revealed true migration of Implanon to be rare. A change of practice locally is described.

J Fam Plann Reprod Health Care 2005; **31**(1): 71-72
(Accepted 3 June 2004)

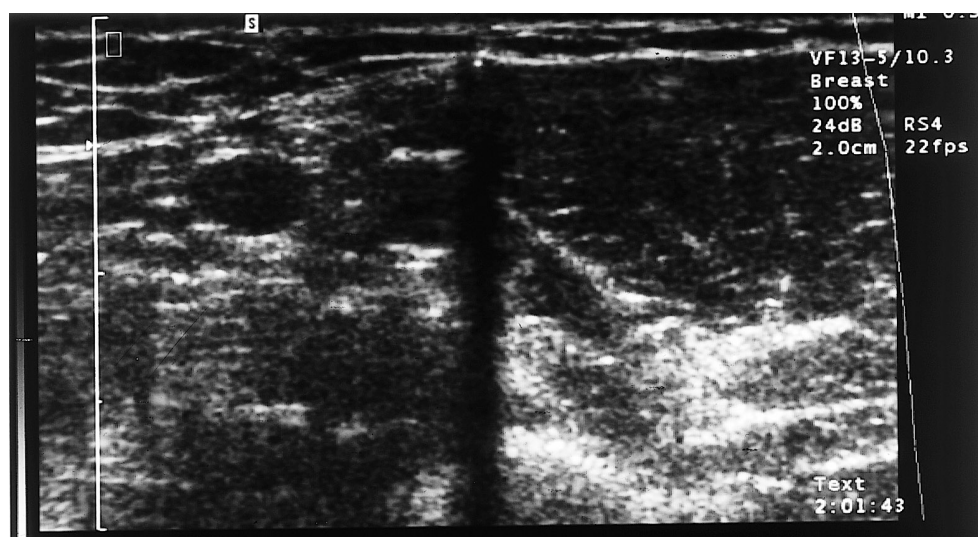
When she attended for renewal in February 2003 the Implanon was not palpable. Ultrasound examination, using a 13.5 MHz linear array transducer, located the distal end subcutaneously (Figure 1) 7.3 cm from the insertion site (as noted by a 2 mm white scar on the upper arm). The proximal end was lying 5 mm deep and close to the neurovascular bundle in the upper arm (Figure 2).

Figure 1 Ultrasound image showing the subcutaneous location of the distal end of the Implanon® device in Case 2 as noted by posterior acoustic shadow

This woman has congenital heart disease with shunt, requires oxygen at night, and is fully anticoagulated with warfarin. Subcutaneous infiltration with local anaesthetic for attempted removal of the Implanon under ultrasound guidance resulted in haematoma formation and the procedure was abandoned. After discussion, it was decided to leave the original Implanon *in situ* permanently rather than risk removal.

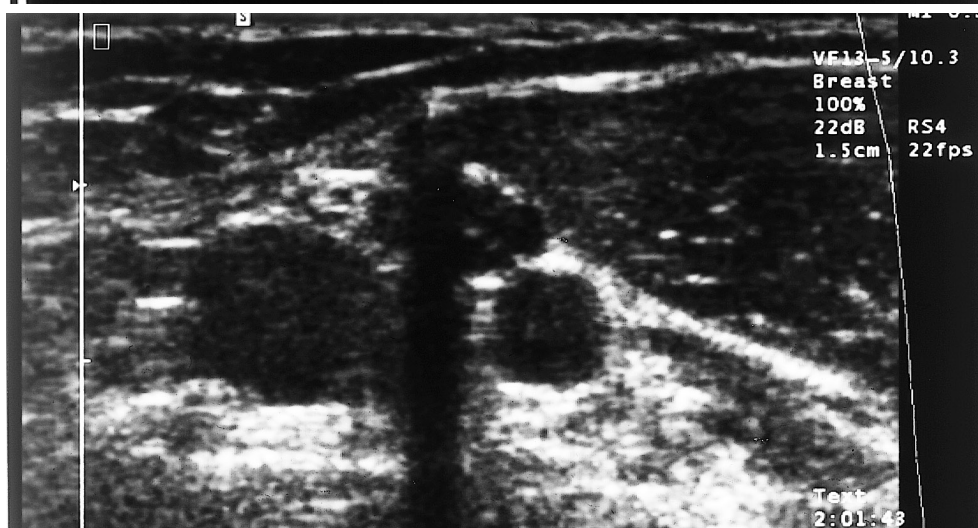
Figure 2 Ultrasound image showing the location of the proximal end of the Implanon® device in Case 2 lying close to the neurovascular bundle
