Location and removal of non-palpable Implanon® implants with the aid of ultrasound guidance

Madan Singh, Diana Mansour, David Richardson

J Fam Plann Reprod Health Care 2006; **32**(3): 153-156
(Accepted 4 January 2006)

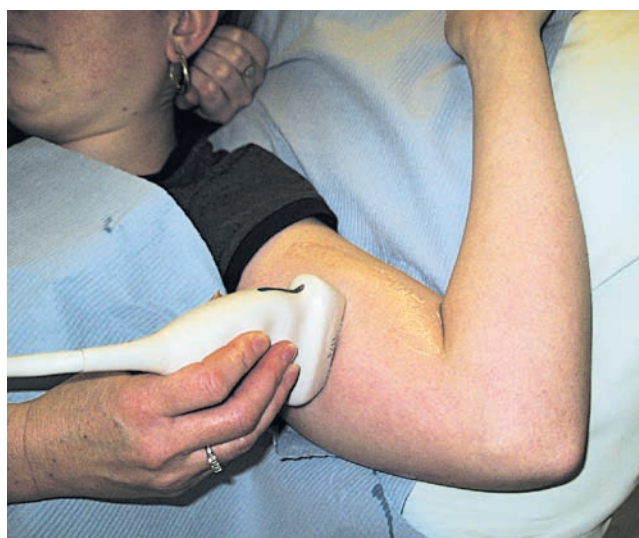
Figure 1 Ultrasound probe placed perpendicularly to the humerus

The localisation of Implanon was carried out using high-frequency linear array probes (7–10 MHz, Siemens Sonoline Elegra or Toshiba Powervision 7000 machines) with the probe placed directly on the skin with coupling gel. The arm was placed in the same position that is required for removal (usually abducted at the shoulder with the patient's hand behind her head). Scanning was commenced initially perpendicular to the length of the humerus in the region of the insertion scar and then rotated to a longitudinal position (Figures 1 and 2).

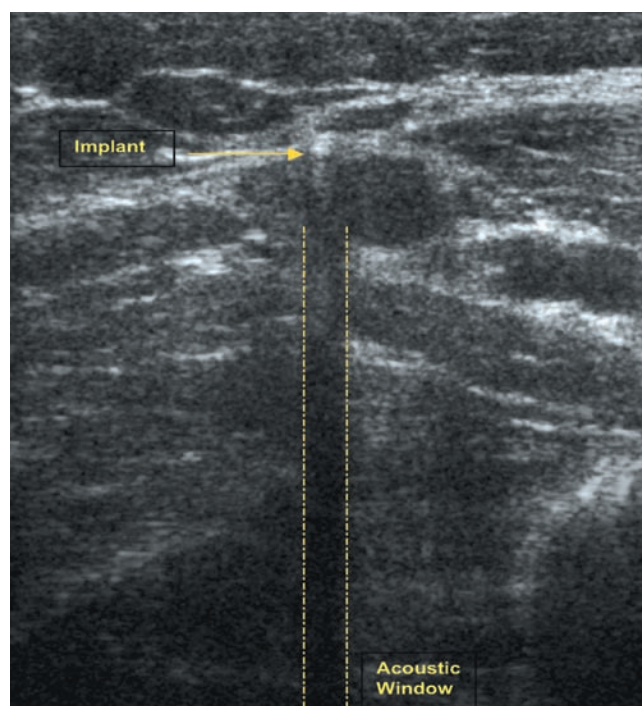
Figure 3 Ultrasonographic image showing Implanon® location in the transverse plane demonstrating the acoustic shadowing

The implant is most easily located by the acoustic shadowing created by the rod as a thin, dark wedge extending deep to the rod. A bright 'dot' representing the implant, at the apex of the acoustic shadowing, may be seen. Once this is seen the ultrasound probe is rotated through approximately 90° to be in line with the implant. The bright reflection of the implant is then appreciated (Figures 3 and 4).

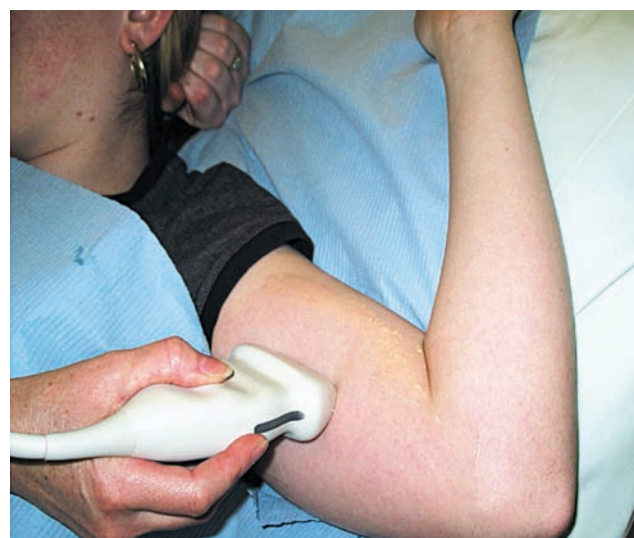
Figure 2 Ultrasound probe placed longitudinally to the humerus

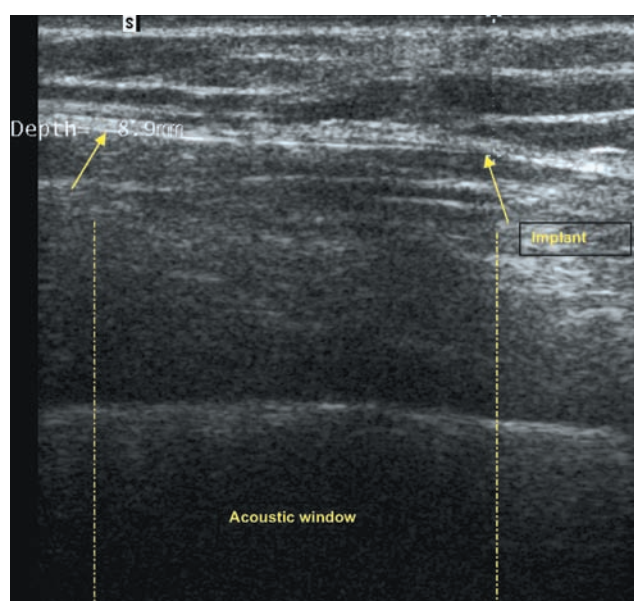
Figure 4 Ultrasonographic image showing Implanon® location in the longitudinal plane
