## Mirena IUS: displacement of the outer hormone sleeve during removal

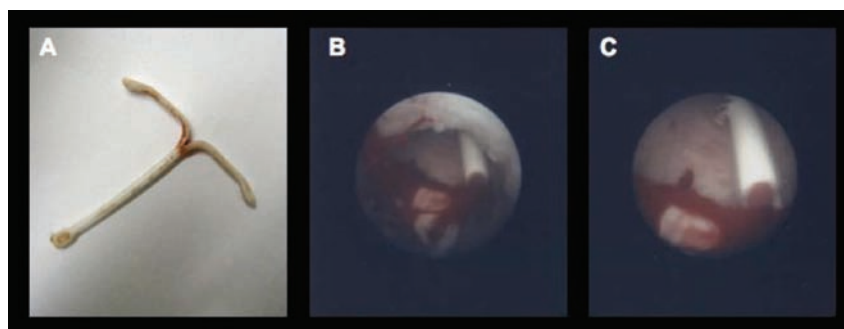
**Figure 1** (A) Mirena® intrauterine system without hormone sleeve, (B) hormone sleeve in uterine cavity and (C) hormone sleeve in uterine cavity.

(CIN 2) smear and the cervical lesion was cauterised. On insertion of the speculum, the threads were clearly visible but on attempting removal, the opening of the os was noted to be stenosed. The threads of the IUS were caught using sponge forceps and moderate traction was required to remove the device. It was quite a difficult removal although not overly so. However, on removal of the IUS, its appearance was unusual (Figure 1A). It appeared to have been removed without the outer hormone sleeve that would usually sit around the IUS stem. The IUS was not replaced and the patient was referred to the gynaecological outpatient clinic.

In theatre, the cervix was noted to be markedly stenosed and required dilatation using Hegar's dilators. Once the cervix was dilated, hysteroscopy was performed. At hysteroscopy, the retained outer sleeve was easily located lying loose in the endometrial cavity (Figure 1B, 1C). This was grasped with toothed forceps via the hysteroscope and removed. It was examined and found to be intact with no evidence of any split in the sleeve. At the patient's request, a new IUS was inserted.

the outer hormone sleeve slipped over the IUS arms and became free, remaining in the uterine cavity. Extra care should be taken when removing an IUS if the cervix has been cauterised since insertion.

Following removal of the IUS, it is essential that the device be inspected to ensure that it has been removed completely. In most cases, the device will be removed easily and appear normal. Very occasionally the outer hormone sleeve will slip up over the horizontal arms during removal but the knobs at the end of these arms will usually prevent the outer sleeve slipping off completely. In such a situation the IUS can still be removed complete. Should the outer hormone sleeve slip over the arms and remain in the uterine cavity, as occurred in this case, the patient should be referred to the gynaecological outpatient clinic for further management.
