Lost IUD penetrating bladder wall

Two cases of broken Implanon®

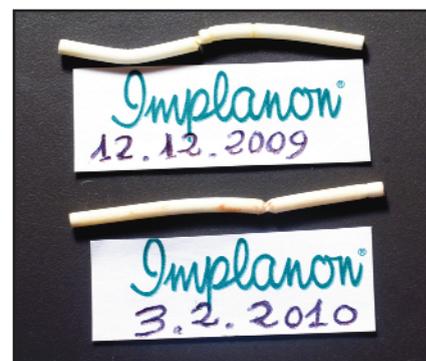
Figure 1 Photograph showing the two broken implants removed from our clients' arms

only joined by the fine sheath. It had two further breaks and was also bent (Figure 1). On questioning, the client admitted that she often played with the implant.

The second client was 22 years old. She had used condoms previously when one split and she became pregnant. Her implant was fitted after a termination of pregnancy in April 2007. She was happy with her implant initially but later she experienced irregular prolonged bleeding and so she was 'topped up' with the combined oral contraceptive pill, which controlled the bleeding as long as she took the pills regularly. The client was seen in clinic on 3 February 2010 after she had decided to have her implant removed and continue taking the combined pill. The implant was subdermally situated in her left inner upper arm over the triceps and felt intact. It was removed easily by means of the 'pop-out' technique. This implant was also broken into two halves (Figure 1), and once again the client agreed that she played with her implant a lot.

We have been experimenting with the implants we removed and feel that the only explanation could be a repetitive bending action that weakens the structure of the rod. We tried bending one of these implants around 200 times and only managed to bend it not break it.

We could find only one published article referring to another case of a broken Implanon.¹ In this case and in our two cases there was irregular bleeding. As Pickard and Bacon suggested in their article, the broken implant could result in an inadequate release of the etonogestrel and thus be responsible for the irregular bleeding. These authors recommended that if a broken implant is suspected of causing irregular bleeding then it should be replaced.¹
