## LETTERS TO THE EDITOR

# Incomplete removal of an intrauterine system

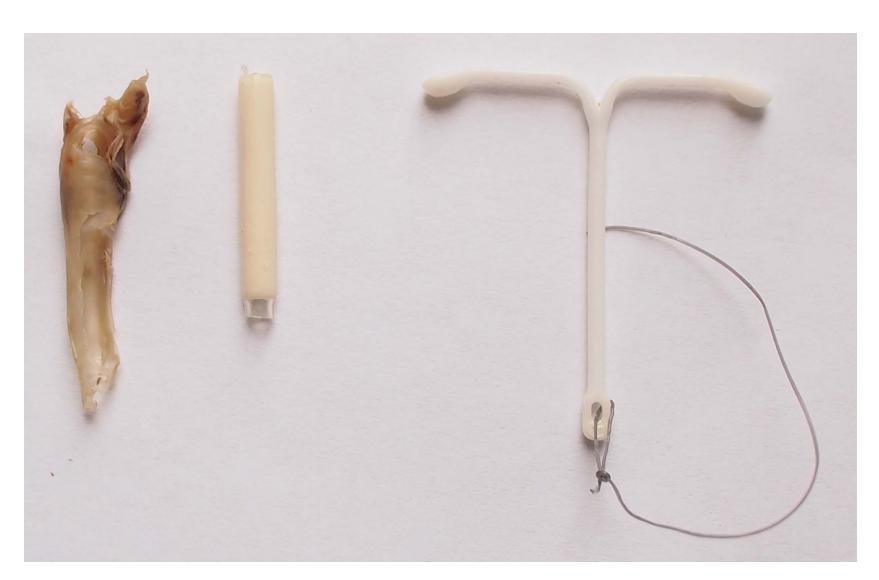
**Figure 1** Left to right: enveloping fibrous tissue; silicone hormonal sleeve after removal from uterine cavity; T-shaped plastic frame of original intrauterine system.

At hysteroscopy, moderate intrauterine adhesions were found. After hysteroscopic electrosurgery to divide the adhesions, the retained outer sleeve of the IUS was seen with fibrous tissue wrapped over its surface. It was grasped with forceps via the hysteroscope and removed from the uterine cavity. Menses were resumed 3 weeks later.

In the present case, we believe that the hormonal cylinder was left in the cavity upon removal because of intrauterine adhesions. Unlike copper IUDs, the IUS has a silicone sleeve surrounding its vertical stem, containing the active progestogen, LNG. The knobs at the end of the two arms can usually prevent the outer sleeve slipping off completely if it loosens, but in this case the sleeve slipped past the horizontal arms during removal. Alanko et al.<sup>3</sup> pointed that if the IUS is used for more than 5 years, the hormone cylinder may become progressively looser, and sliding may therefore become more frequent. But in this case the IUS had been in situ for only 13 months.
