# CASE REPORT

## Magnetic resonance imaging appearances of the Mirena and GyneFix intra-uterine contraceptive devices: A report of two cases

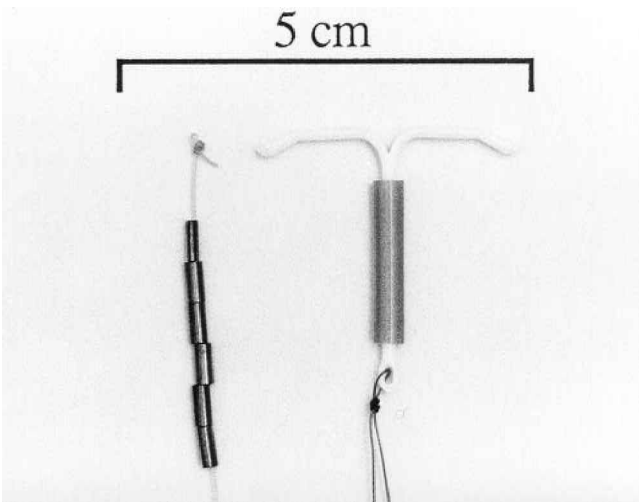
**Figure 1** A GyneFix contraceptive implant (left) and a Mirena intra-uterine device (right)

The second case is that of a 23-year-old multiparous woman who had a GyneFix copper intra-uterine contraceptive implant fitted for contraceptive purposes 6 months previously (Figure 1). She complained of right-sided pelvic pain, which was worse prior to and during menstruation, and was referred for diagnostic laparoscopy. However, the procedure was abandoned due to technical difficulties prior to visualisation of the pelvic cavity. Thus she was referred for MRI assessment of the pelvis, which was performed as described for the first case.

sulphate impregnated, plastic, T framed device, the stem of which is surrounded by a reservoir of levonorgestrel enclosed in a slow release membrane. The efficacy of this device equals that of sterilisation, but yet it remains fully reversible. The GyneFix system is essentially six tubular copper beads suspended on a nylon thread that is anchored to the myometrium at the level of the fundus by a small knot. The beads lie adjacent to one another without any space intervening and so appear like a continuous piece of very narrow hollow copper tube. This system avoids drugs

and relies on the contraceptive effects of a high surface area of copper (330 mm<sup>2</sup>). Dispensing with the plastic frame reduces the side effect of dysmenorrhoea, and anchoring the device in the myometrium obviates the risks of contraceptive failure due to slippage or expulsion.

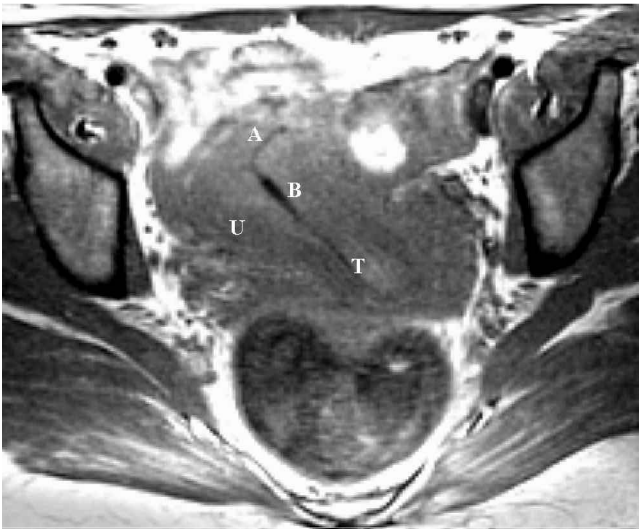
**Figure 2a** T1 weighted axial image of pelvis showing arms (A), barrel (B) and retrieval threads (T) of the Mirena system within the uterus (U)

The left ovary demonstrated two cystic lesions, one a simple cyst, the other an endometrioma. The Mirena intra-uterine system was clearly seen as an area of lower signal intensity on both the T1- and T2-weighted images, within the endometrial cavity. The thickened hormone reservoir on the barrel of the device and the flattened wing arms of the device could be clearly seen, as indeed could the rounded ends of the arms and the retrieval threads (Figure 2).

The MRI appearances of these two new intra-uterine devices have not previously been described. There is a trend in contraceptive medicine to avoid systemic administration of drugs, if possible, whilst maximising contraceptive efficacy. These two new devices closely approach these objectives. With the Mirena system we have entered a new era of intra-uterine drug delivery, with uses beyond contraceptive practice (e.g. levonorgestrel treatment of menorrhagia<sup>1-3</sup>). The Mirena device is essentially a barium

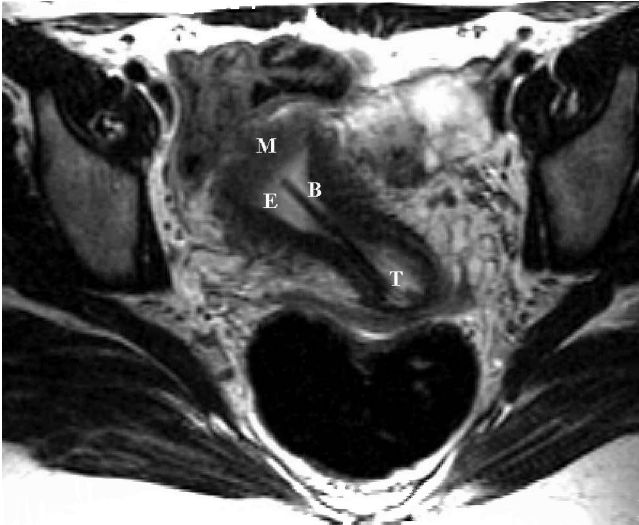
**Figure 2b** T2 weighted axial image demonstrating the barrel (B) and the retrieval threads (T) of the Mirena system within the uterus. The endometrial cavity (E) appears light and is surrounded by the dark myometrium (M)

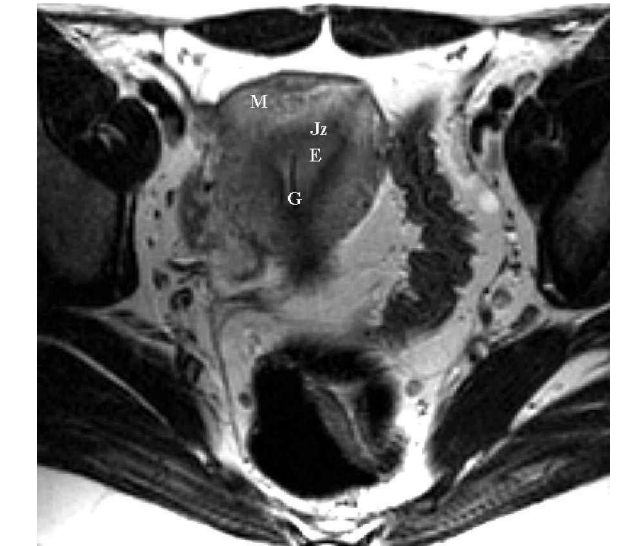
**Figure 3a** T2 weighted axial image demonstrating the dark copper beads of the GyneFix system (G) with the light endometrial cavity (E). The tip of the device is seen to abut the darker junctional zone of the myometrium (Jz) where the knot is anchored, and this is surrounded by the lighter outer myometrium (M).

No intra-pelvic abnormality was demonstrated to account for the patient's pain, but the GyneFix intra-uterine implant was seen on both the T1- and the T2-weighted images as a linear signal void in the centre of the endometrial cavity. The images clearly show the device to be correctly sited, anchored to the fundus in the midline (Figure 3).

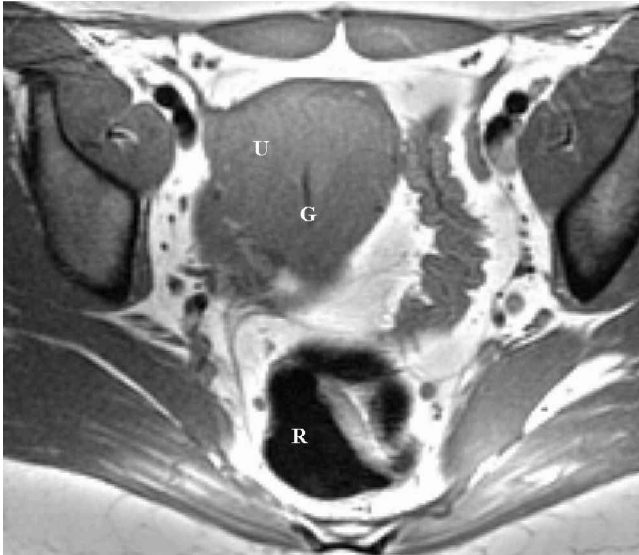
**Figure 3b** T1 weighted axial image demonstrating the dark GyneFix system (G) within the uterus (U). Note the zonal anatomy of the uterus is not seen on a T1 weighted image. The rectum (R) is seen posteriorly.

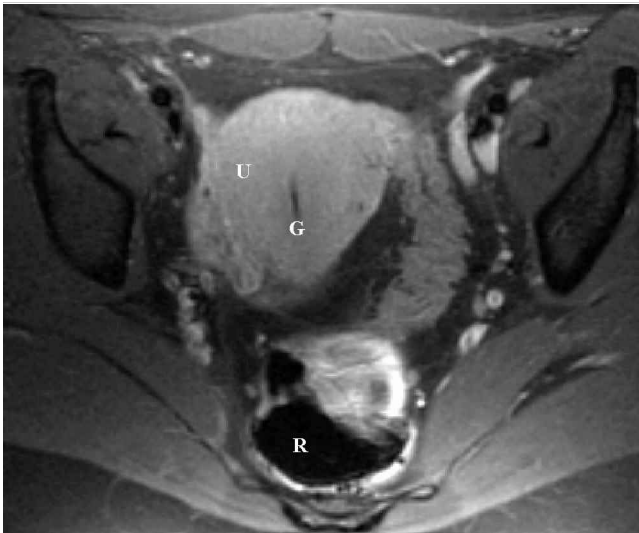
**Figure 3c** Post-contrast fat-suppressed T1 weighted axial image demonstrating the GyneFix system (G) within the uterus (U). The rectum (R) is seen posteriorly.
